It appears there are surface cracks on the thread flanks that are origination sites for a lot of the white rust, and some red rust.
 Theory: The surface cracks are entrapping and retaining plating fluids (acids) in the plating process. These cause quick appearance of the rusts in the thread flanks.

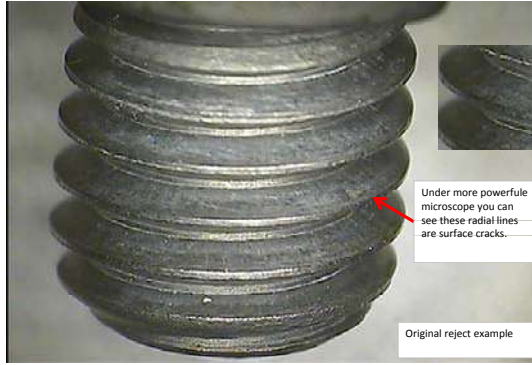
Original reject example

Under more powerful microscope you can see these radial lines are surface cracks.

Look for radial lines sort of like this in all the pictures.

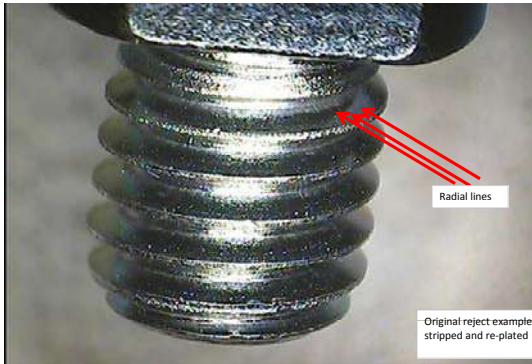
Original reject example stripped and re-plated

Radial lines

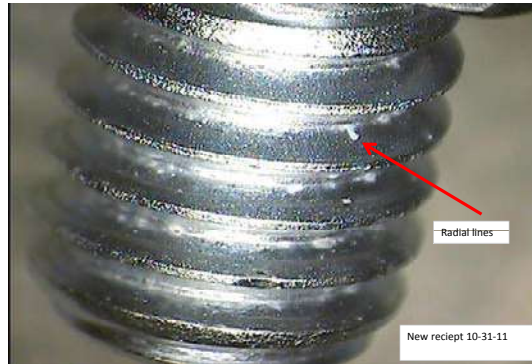
New receipt 10-31-11

Radial lines

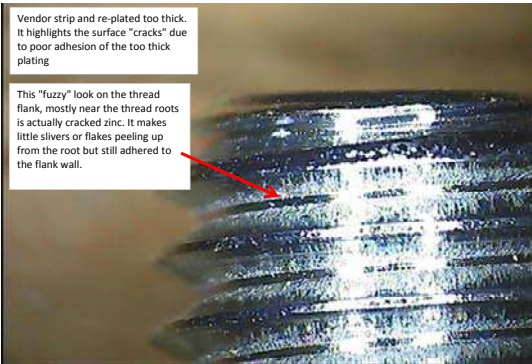
Vendor strip and re-plated too thick. It highlights the surface "cracks" due to poor adhesion of the too thick plating

This "fuzzy" look on the thread flank, mostly near the thread roots is actually cracked zinc. It makes little slivers or flakes peeling up from the root but still adhered to the flank wall.

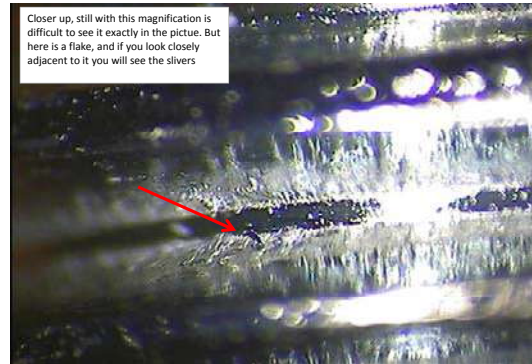
Closer up, still with this magnification is difficult to see it exactly in the picture. But here is a flake, and if you look closely adjacent to it you will see the slivers

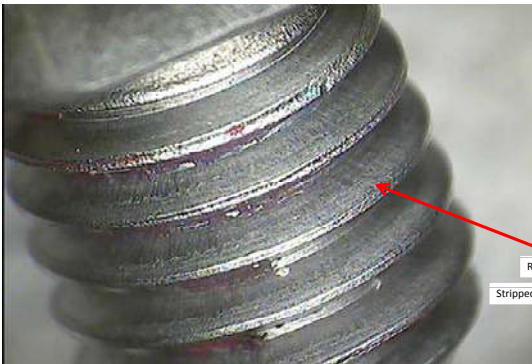
Stripped part example.

Radial lines
