# **PREMATURE ELECTRICAL FAILURES IN AUTOMOTIVE STARTER SOLENOIDS DUE TO TERMINAL CONTAMINATION & CONTACT EROSION**

Improvements in design & evaluation by experiments

**AUTO IGNITION LTD., INDIA**

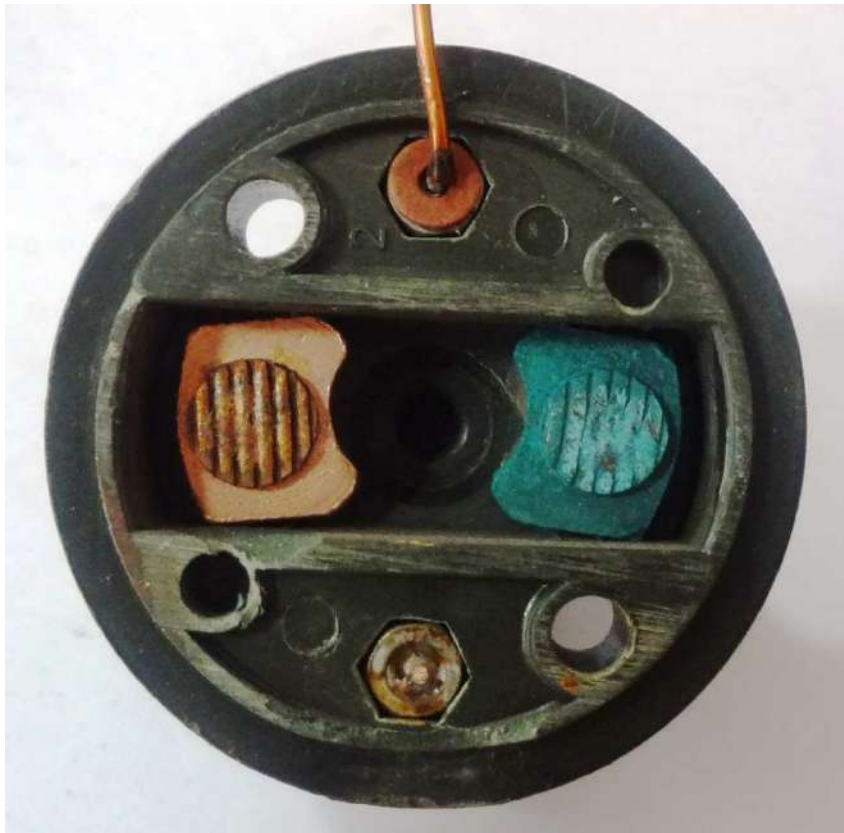
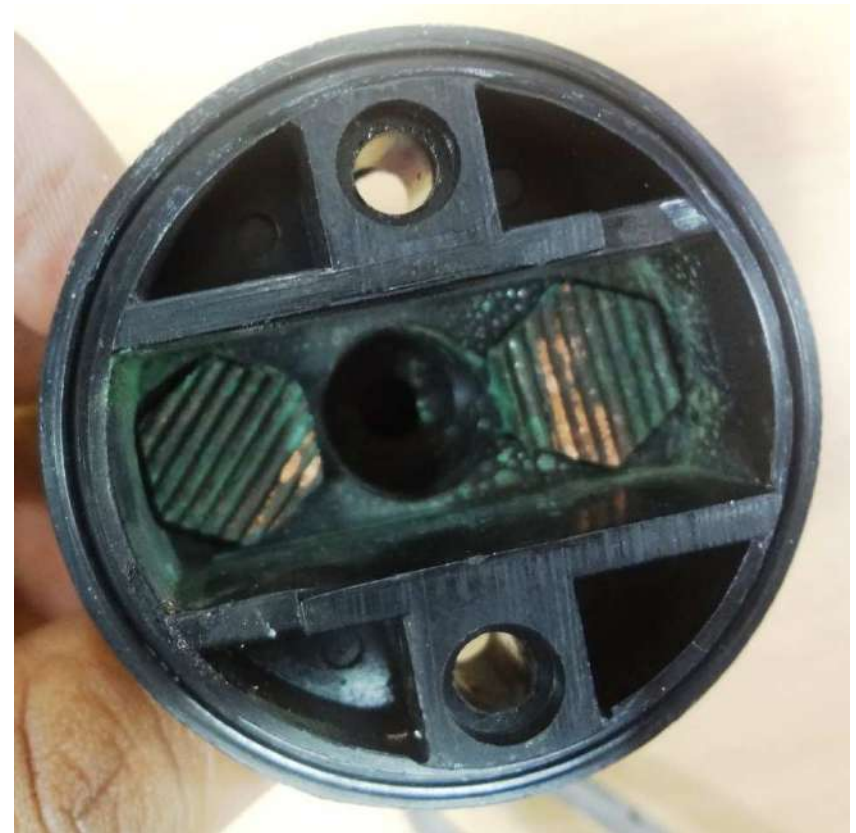
## CASE STUDY FOR ELECTROSTATIC & GALVANIC CORROSION

[ Non conductive Copper Chloride & Copper Hydroxide deposits on battery terminal  
in case of electrostatic & both terminals in case of galvanic corrosion]

- Copper plating on copper terminals & contact plate to be eliminated & cleaning process to be improved with better controls to eliminate acid & alkali residues in the finished components to prevent reaction with copper
- Water based anti oxidant/lacquer to be replaced by alcohol based lacquer
- All steel hardware like nuts, plate & spring washers to be Zinc-Nickel plated and trivalent passivized with a proper top coat to reduce galvanic corrosion.

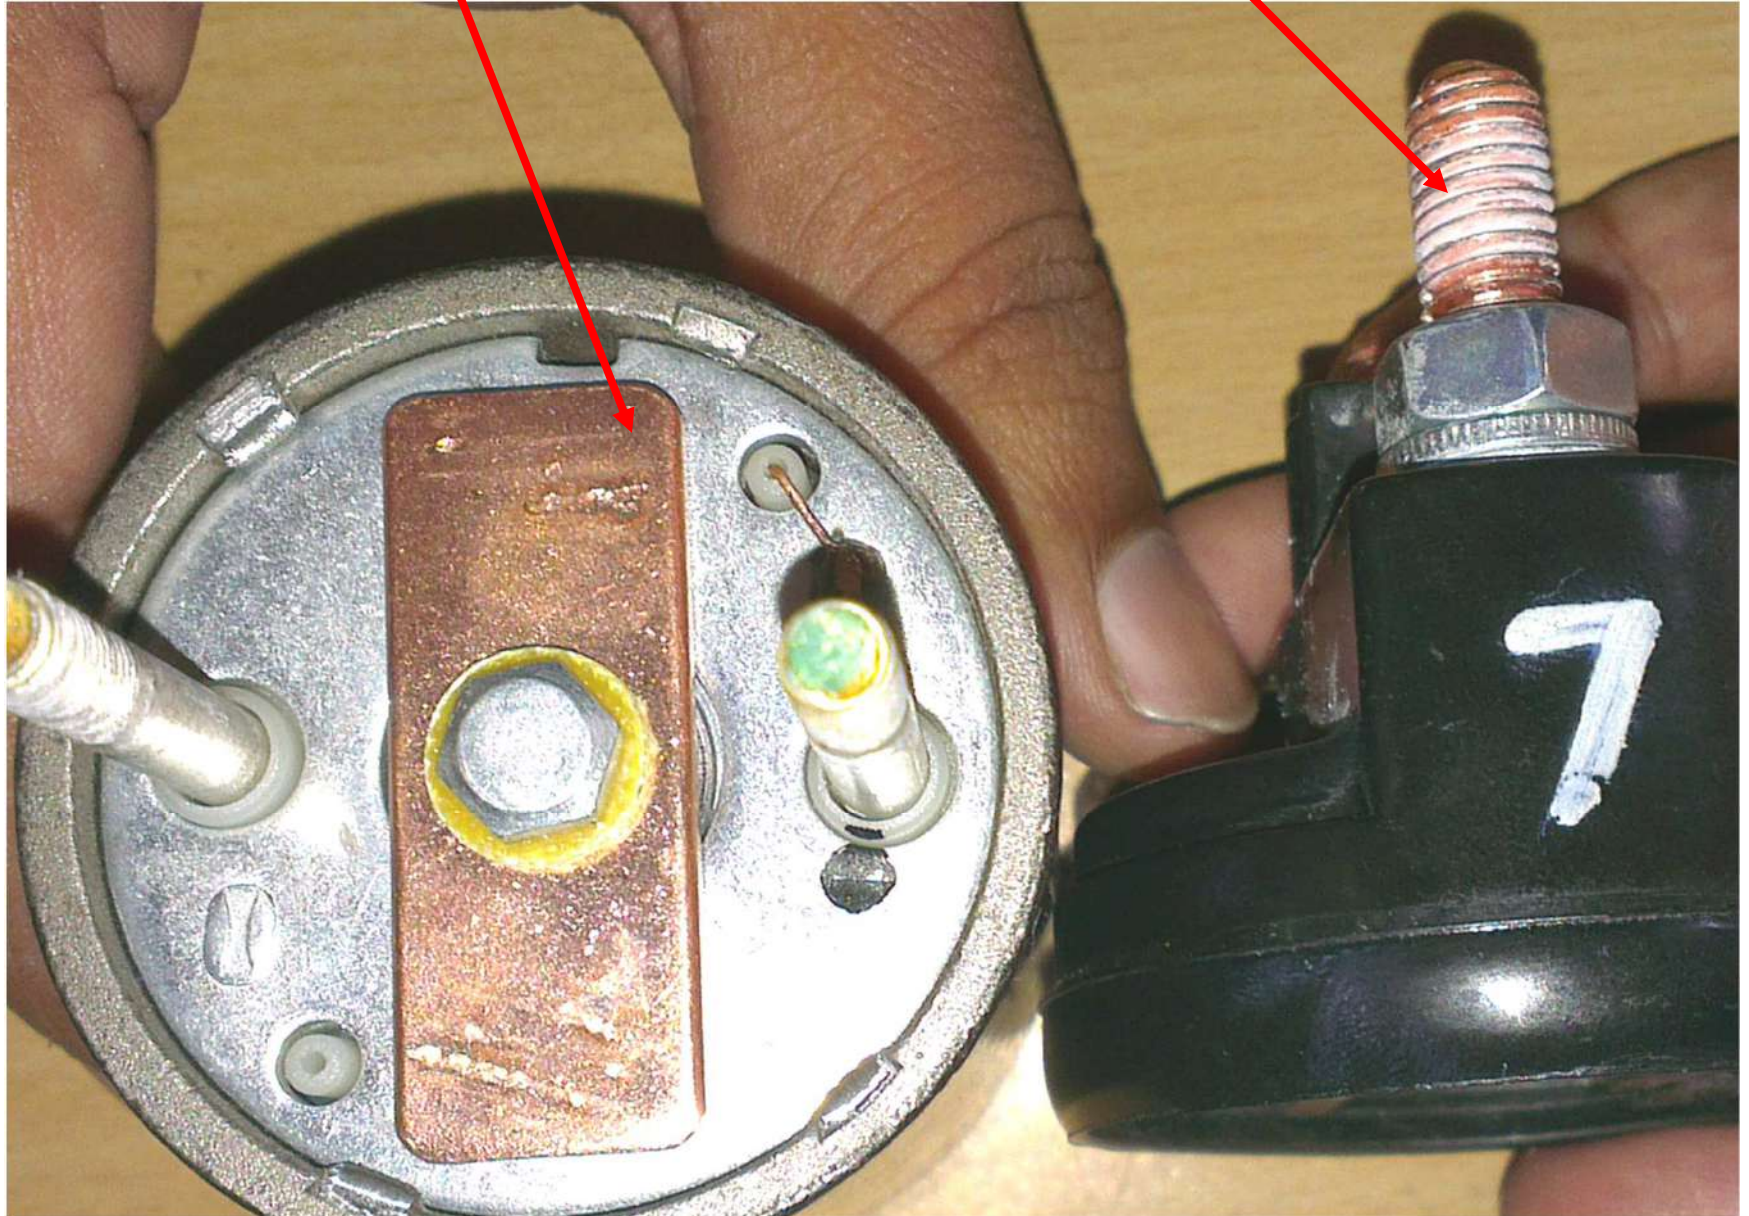
# **Oxidized Contact plate & excess white rust observed in E7** [Solenoid prepared with water based lacquer & zinc passivized hardware]

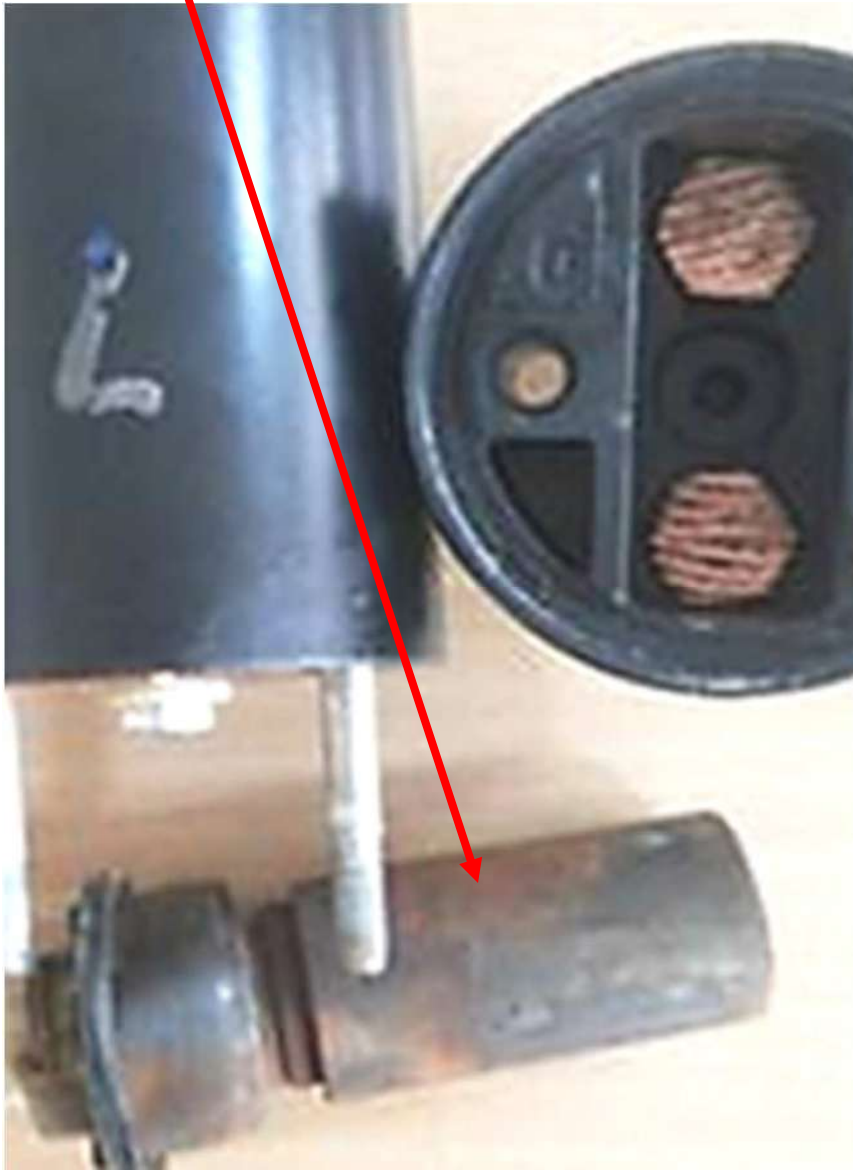
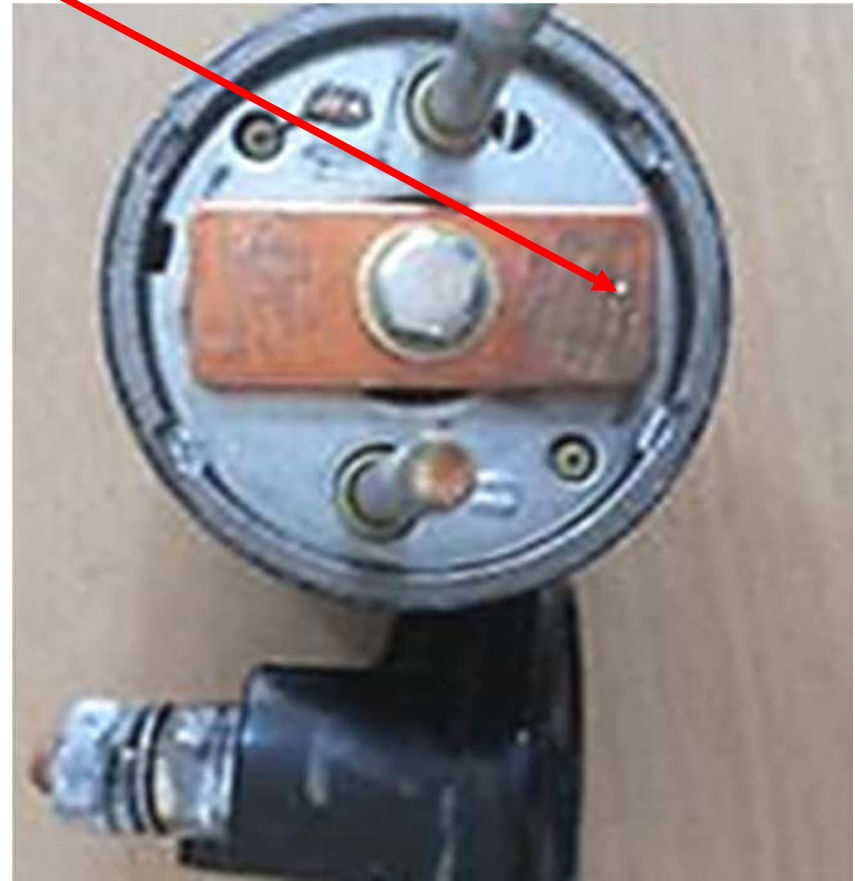
**Contaminated contact plate & copper like coloring on plunger indicating erosion of copper terminals & contact plate**

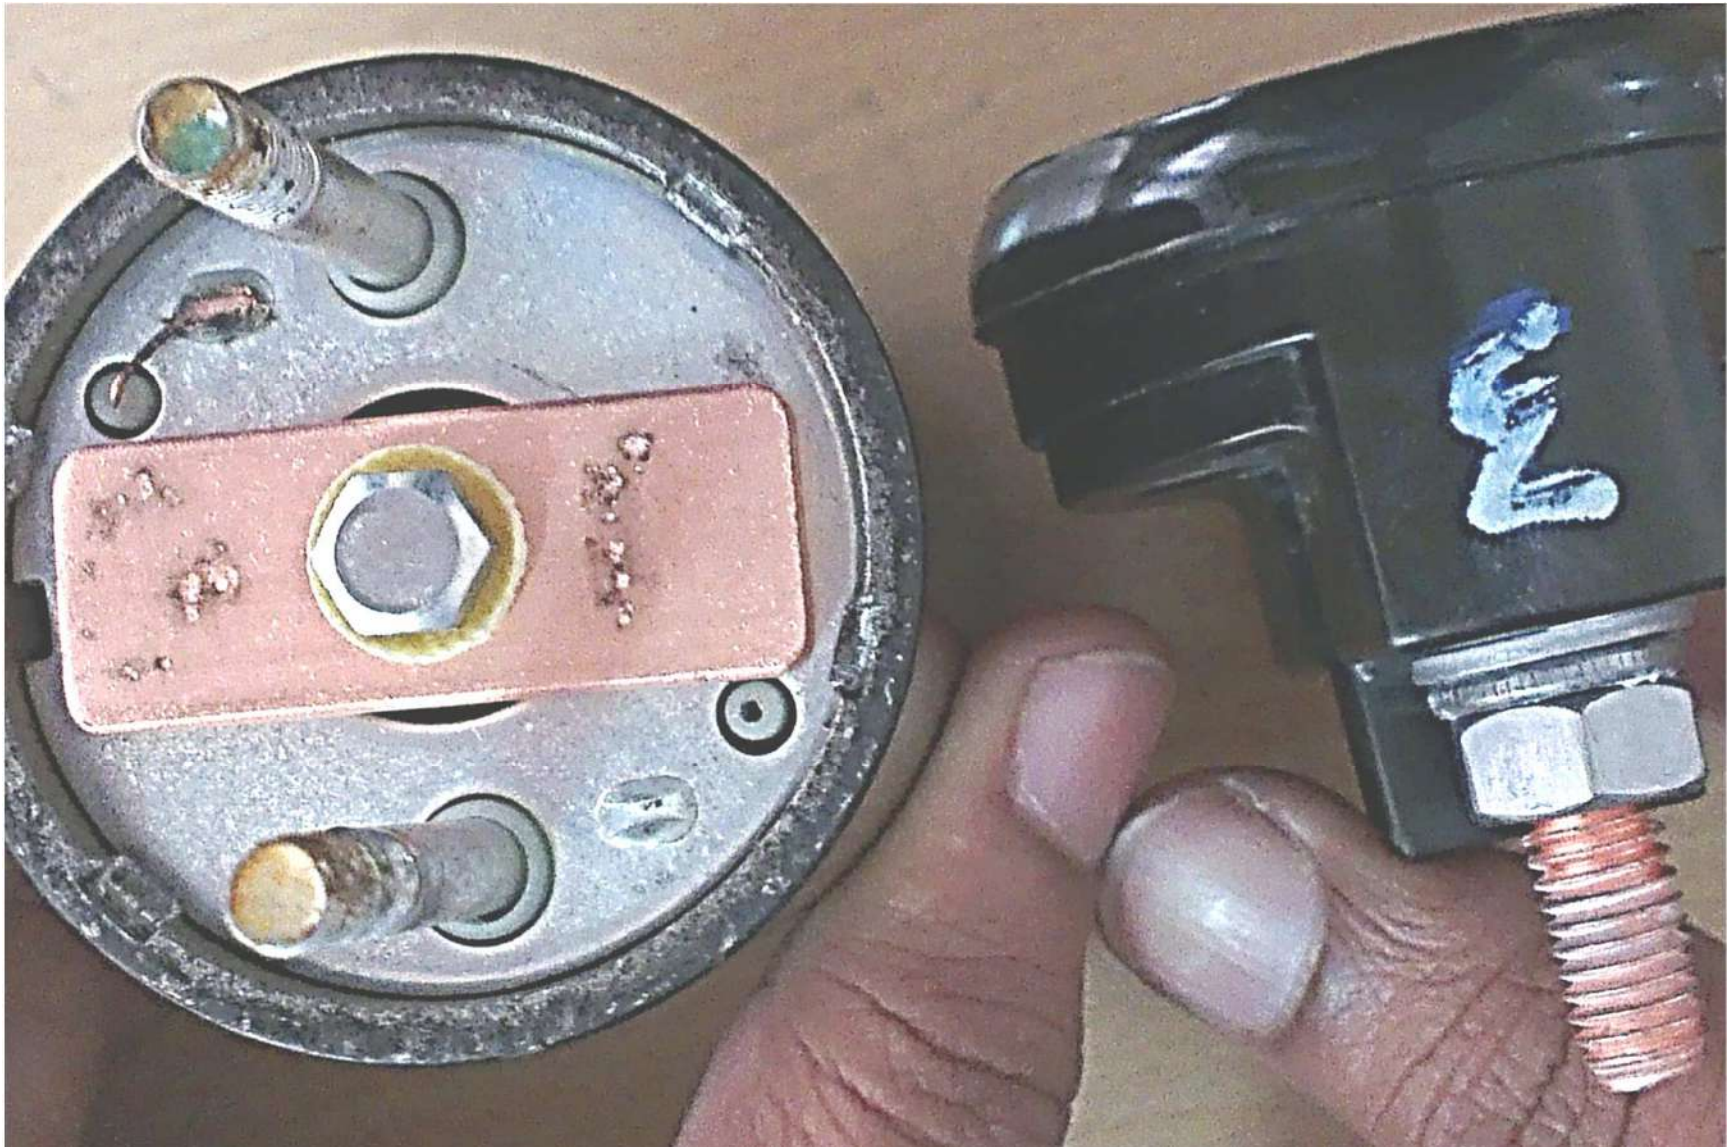
**Clean Contact plate & less white rust observed in M3 in spite of arcing**  
[Solenoid prepared with alcohol based lacquer & zinc nickel passivized hardware ]

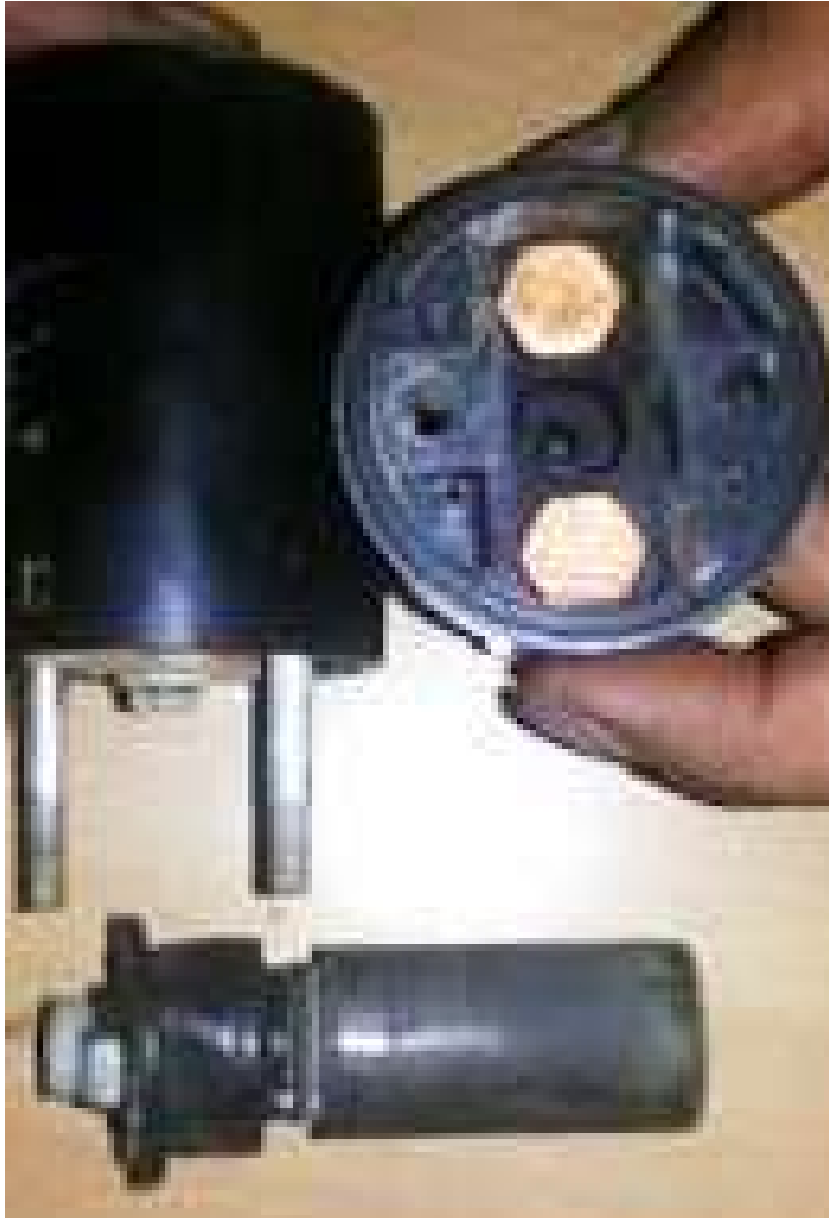
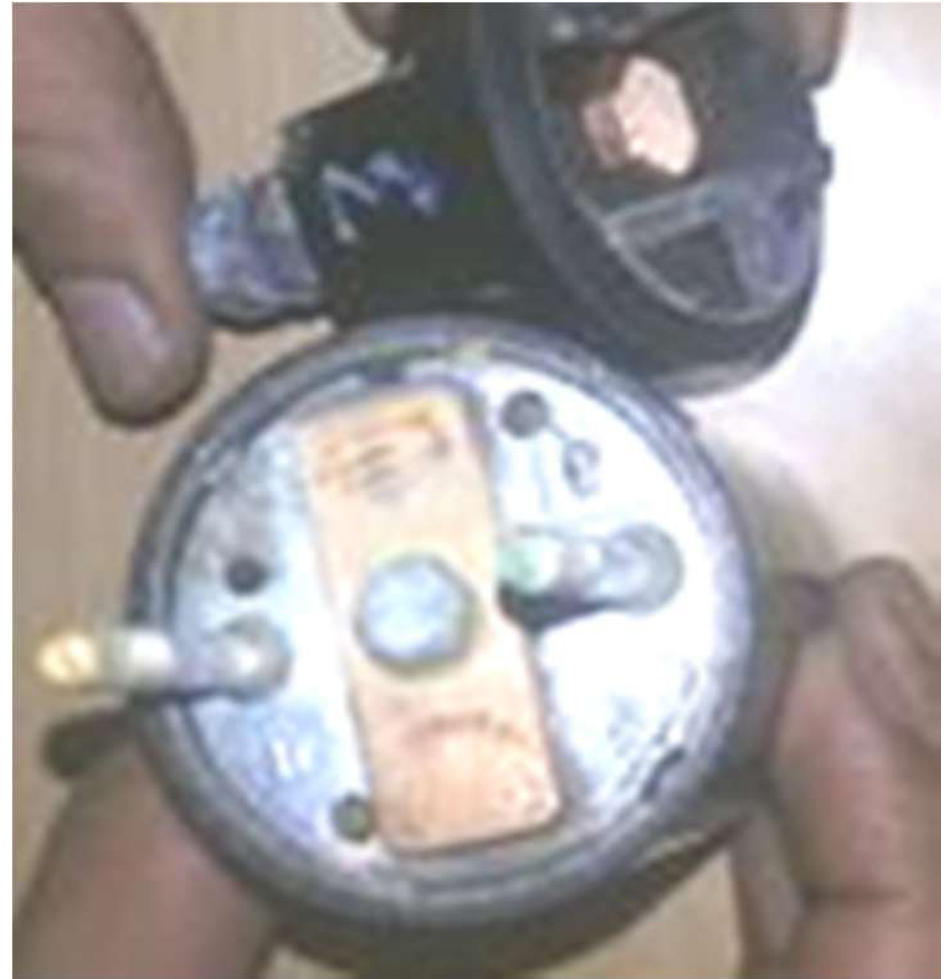
**Cleaner contacts, plate & no coloring on plunger in case of M3**
